New Zealand's unreinforced Masonry Buildings: Facing up to the earthquake.

C P Murphy

Abstract. The damage caused by the 2011 Christchurch earthquake has led to the introduction of compulsory seismic strengthening legislation for all unreinforced earthquake-prone masonry buildings (URM) within New Zealand. The legislation, passed in 2013, requires all such URM commercial, multi-unit and multi-storey residential buildings to be upgraded and strengthened to a minimum of 34% or more of the New Building Standard, irrespective of the earthquake zone within which they are located. Buildings so designated and in high earthquake zones will have a very limited time bring their buildings into line with these requirements. The proposal particularly affects old URM buildings. Some of these are buildings have a declared heritage value, many do not. Most were built around the turn of the twentieth Century. Together they make up a considerable portion of many small town commercial precincts. The legislation affects all parts of New Zealand, regardless of the particular region's exposure to earthquake risk.

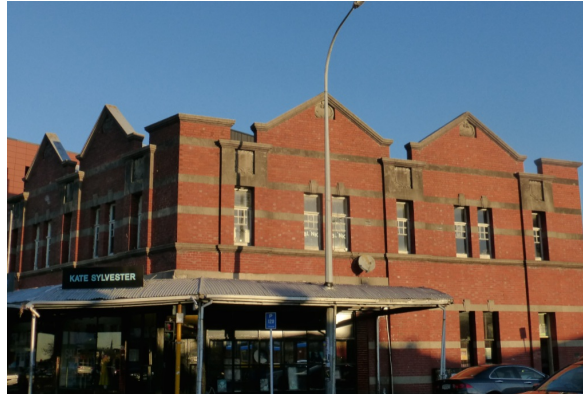
Figure 2 Ponsonby Rd Auckland (Source: C Murphy)

The Building (Earthquake-prone Buildings) Amendment Bill 2013 was introduced into the New Zealand Parliament on 13th December 2013. The intent was to upgrade and improve methods of managing New Zealand’s older and often earthquake-prone buildings. The legislation arose out of the recommendations of the Canterbury Earthquake Royal Commission, [6] a body formed to look at the reasons for the collapsed buildings following the two earthquakes that struck Christchurch city over a six-month period. An earthquake of magnitude 7.1 struck on September 4th 2010. This was followed by another earthquake on the 11th February 2011, this time of magnitude 6.3. The latter earthquake caused extensive damage across the city and caused the deaths of 185 people. Included in the damage were many small, URM retail buildings commonly referred to as “home shop” or “house shop” buildings, the main focus of this paper (Fig 1). This building typology, so called because the shop owners retailed their wares on the ground floor and lived with their families in the upstairs portion of the predominantly two-storey building, formed the core of the many urban streetscape settlements that grew up around the larger cities in New Zealand, mostly between the years 1880+ to the 1920-1930s. In Auckland for example, such centres as Grey Lynn, Ponsonby, Herne Bay, parts of Dominion Rd, Mt Eden, Papakura and old established areas such as Otahuhu all have URM “home shop” buildings as an integral part of the retail streetscape. Other centres are similar. In regional towns further south, such as Wanganui or Marton (one of the case study focuses of this paper), as much as 50% of the streetscape are URM buildings of varying heritage or non-heritage quality. External construction was single, double or of cavity brick construction, often with protruding parapets elaborately adorned. Floors were constructed of timber, with strip timber tongue and groove flooring. Access to the upper floor, where the owner and family lived, was usually by internal stairway (Fig 2).

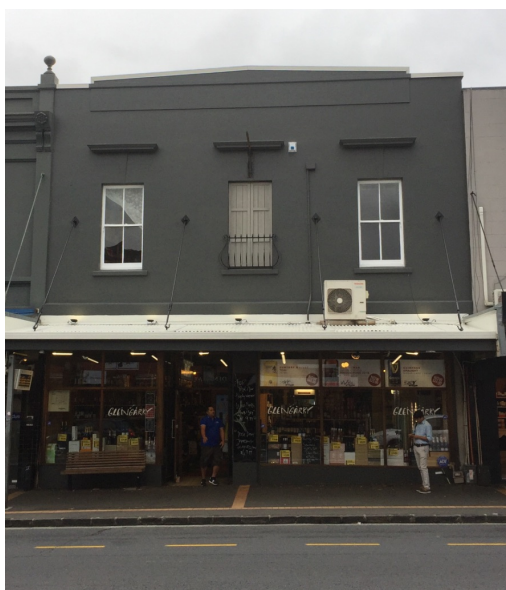
Figure 3: Mt Eden URM Building

Mt Eden, a prosperous secondary rental location with a street heritage substantially effected by the legislation (Fig 3). The plan areas are typical of such buildings, with prime ground floor retail space of a limited size, ancillary spaces to the rear of the ground floor (storage) and the upper floor area, originally given over to “home shop” accommodation for the owner and family, but now predominantly used for a variety of activities, either related to the shop activity or sublet to other tenants. Values are estimates only and variations, depending upon location and condition, can be expected.
